## Case Study

# Detailed Load Monitoring For Movable Architecture

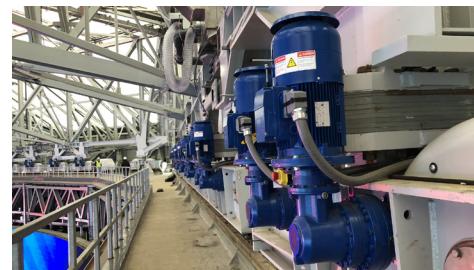
ATA applied and calibrated a measured load to over 200 strain gages on the facility roof

ATA Engineering (ATA) installed over 200 strain gages at planned locations on the load bogies and counter-balance trolleys supporting all eight petals of the operable roof developed by Uni-Systems Engineering for Mercedes-Benz Stadium in Atlanta, Georgia. At all of the load bogies and trolleys, ATA applied and calibrated a measured load to the measured strains. These calibrated loads were measured and monitored during a number of construction movements of the operable roof. Later, new strain gages were permanently installed and calibrated, and ATA assisted Uni-Systems with the installation of a complete data acquisition solution to monitor the bogie and trolley loads for the long-term operation of the operable roof.
